# Survey report

## ELBING IX

Baltic Sea - Lithuania, Klaipeda

23.09.2019

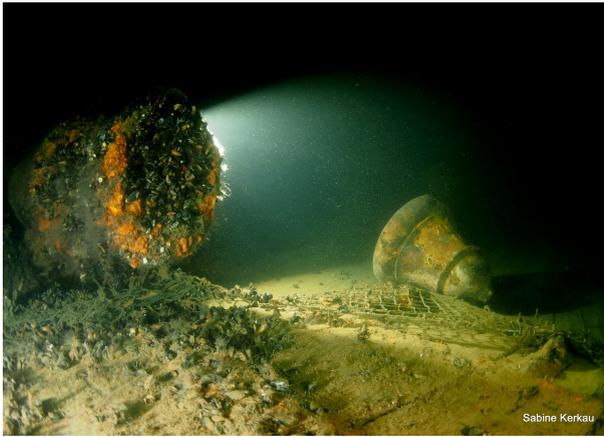
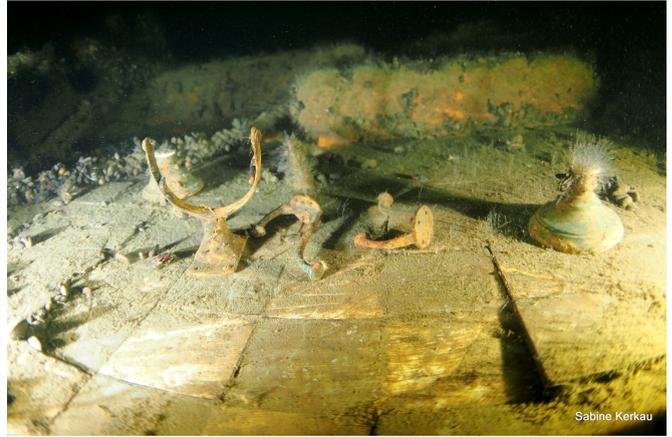
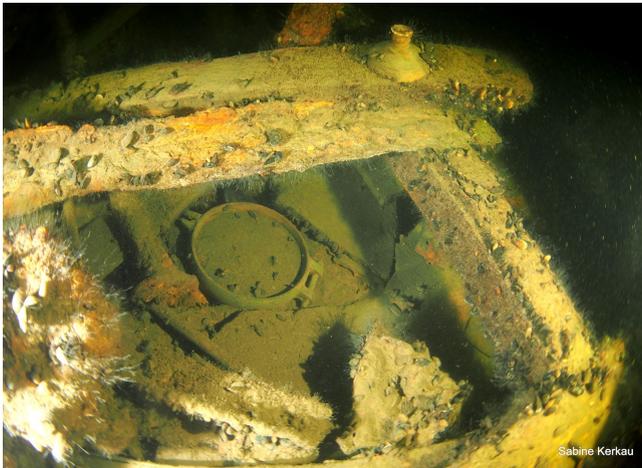
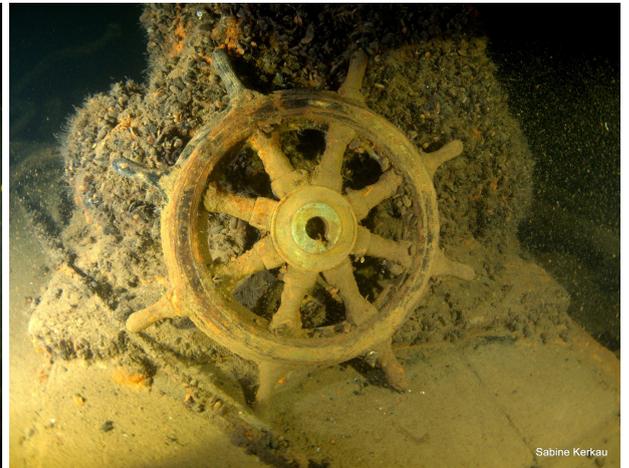
It is a steel ship with a length of 66m above all. It stands upright on sandy soil in about 50m depth. The original shape of the hull can still be seen clearly. The bridge or the top structures are collapsed and largely missing. The ship had three holds; two in front and one behind the bridge construction. The wooden floor of the fore ship is well preserved. The stumps of two large masts stand on deck. Several large winches are located directly on the masts. In the bow area, a large spare anchor leans against a wall. The ship had two screws. One is starboard from the rudder blade. The port side screw lies between crashed remains of the stern. On deck of the stern is a spare screw. Several double cross bollards are on deck. A well-preserved wooden steering wheel was found under nets in the middle of the ship.

A ship's bell with the inscription "ELBING IX" was found under nets at the windlass in the bow. In the second hold is the ship's plate with the inscription "N: 886 F.Schichau Elbing 1913". The wreck has large holes in the rear, resulting from an explosion.

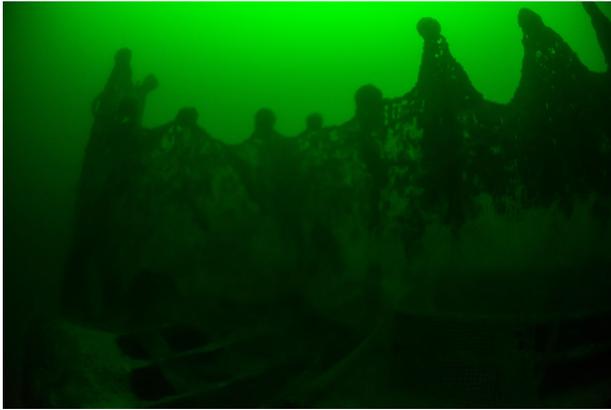
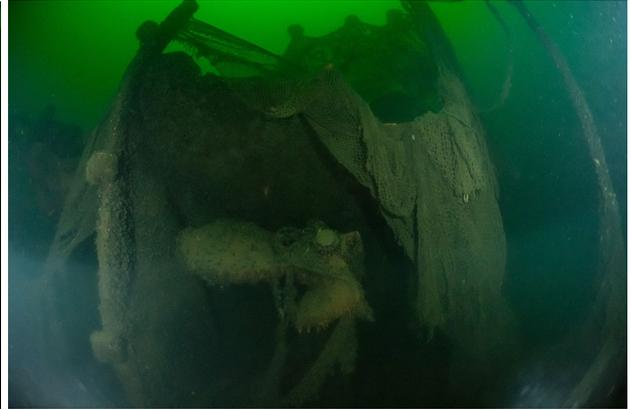
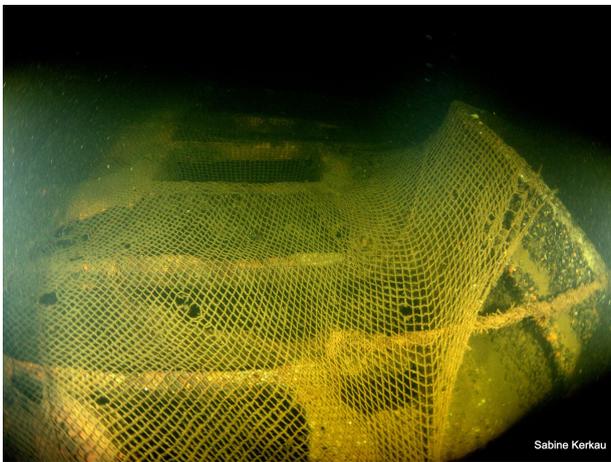
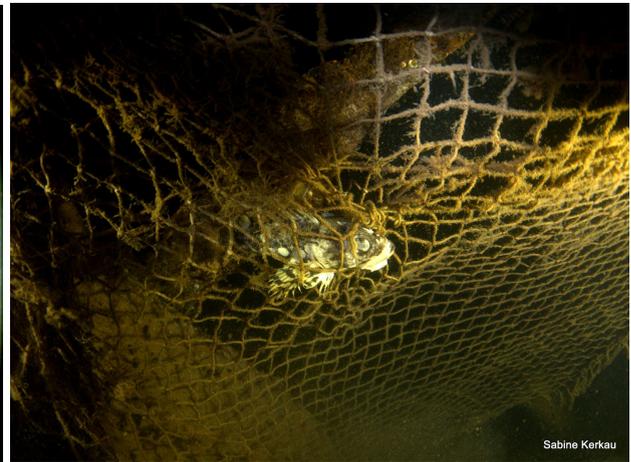
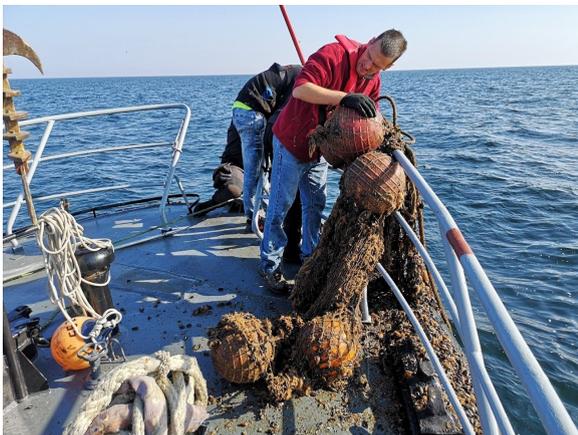
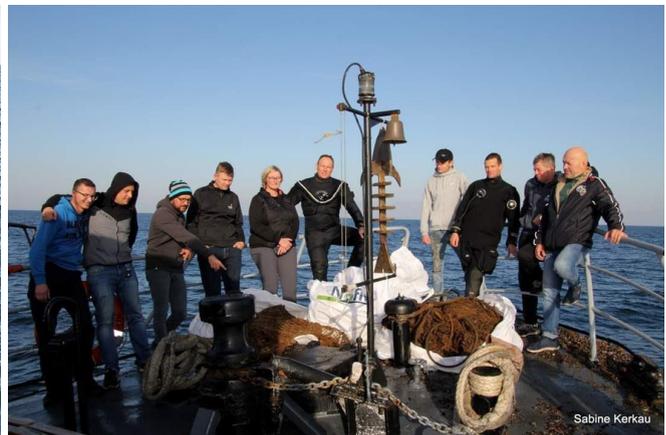
The wreck was covered with fishing nets over large areas. For the animals this is a problem, because these nets continue to fish and kill fishes and other marine animals that are caught in the nets. They do this over many years.

In 2019, teams from the Baltic Sea Heritage Rescue project were able to recover and dispose all major nets on the wreckage of the ELBING IX. This also revealed interesting details that were hidden under the nets.

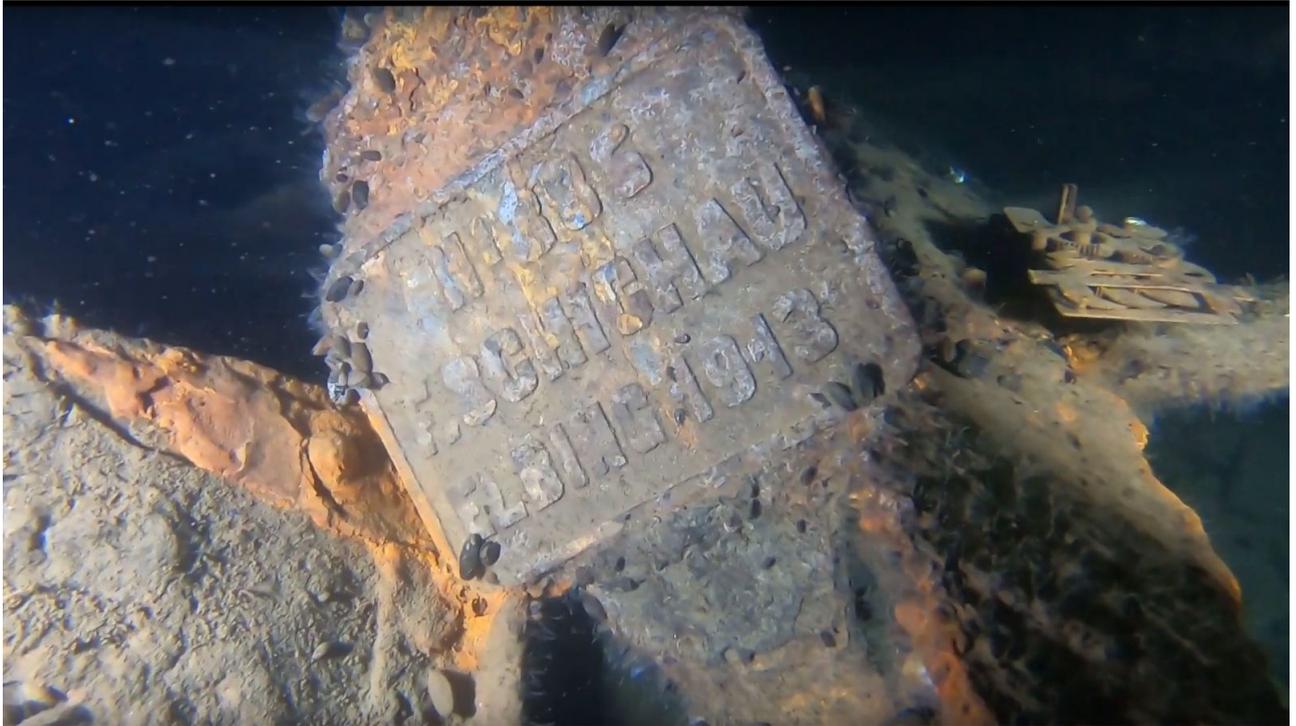
### Ship builders's plate

In the second hold is the ship plate with the inscription:

**N:886**

**F.Schichau**

**Elbing 1913**

The plate is firmly connected to steel girders and therefore clearly belongs to the ship.

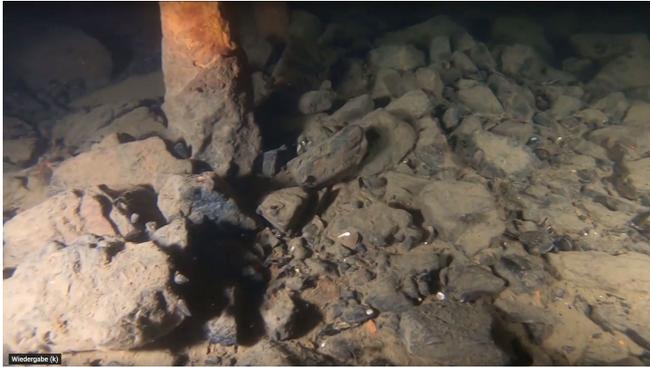
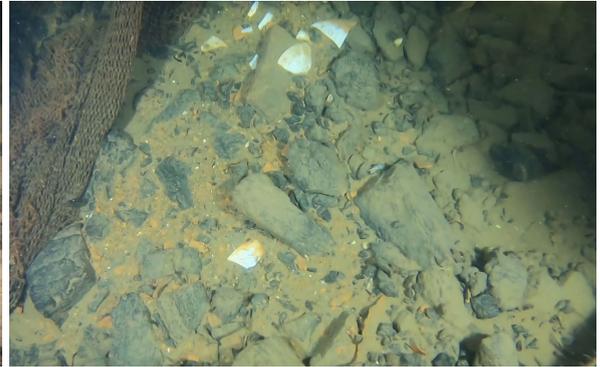
## Cargo:

In the holds is hard coal and some wood.

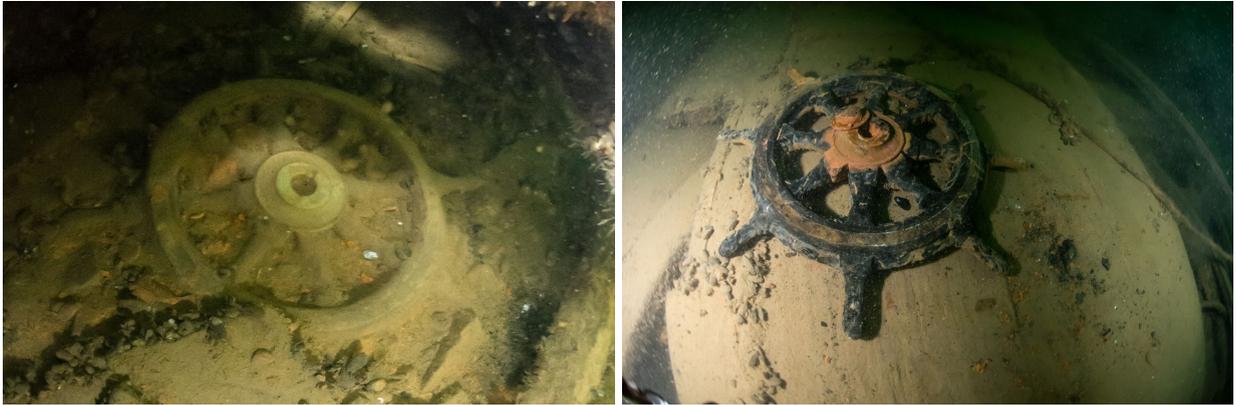
## Steering wheel

The steering wheel at the discovery on 11th July 2018

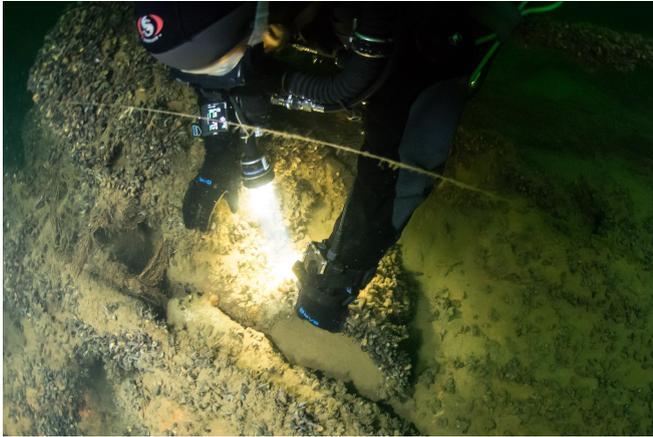
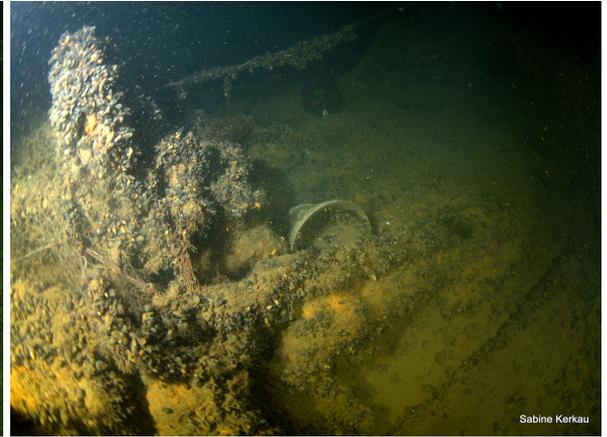
## Ship's bell

The bell at its discovery on July 11th 2018. It lay at the starboard anchor chain in the bow.

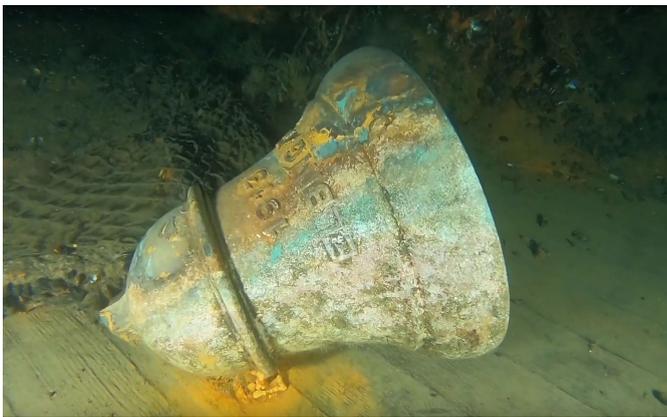
Bell today on the foredeck

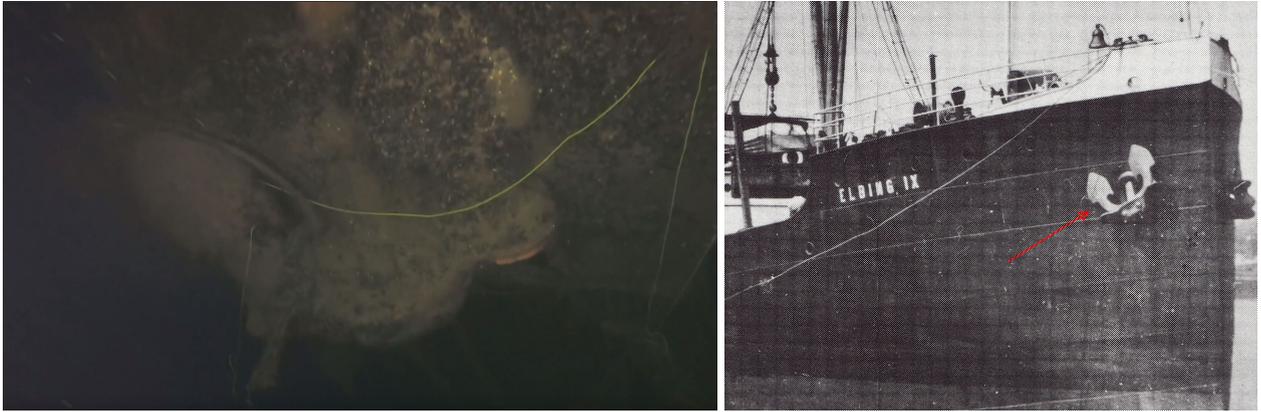
## Anchor

Both anchors at the bow are at their anchorage positions.

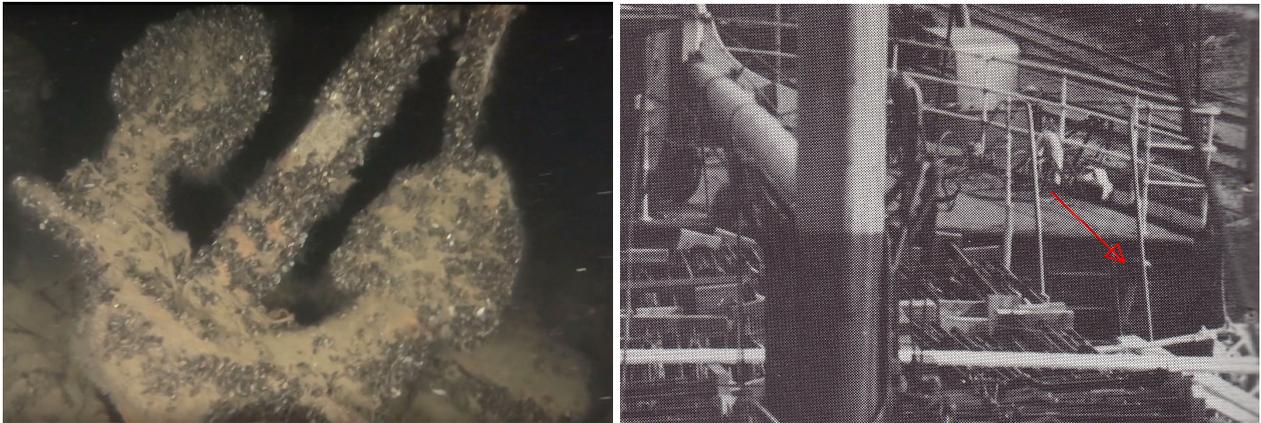
## Spare anchor

Starboard in the bow area leans a spare anchor on the wall to the fore ship.

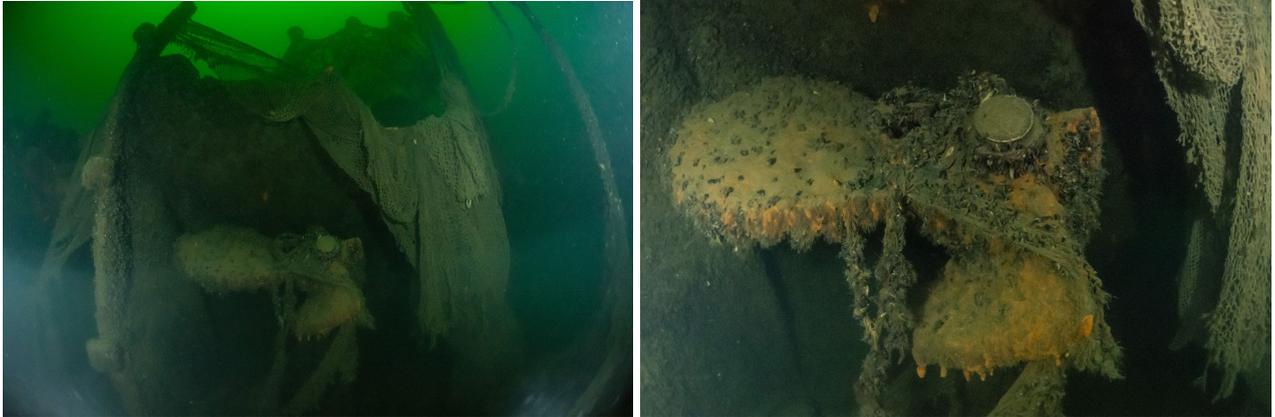
## Starboard screw

This screw is located starboard side of the rudder blade.  
Three blades of the screw are broken off.

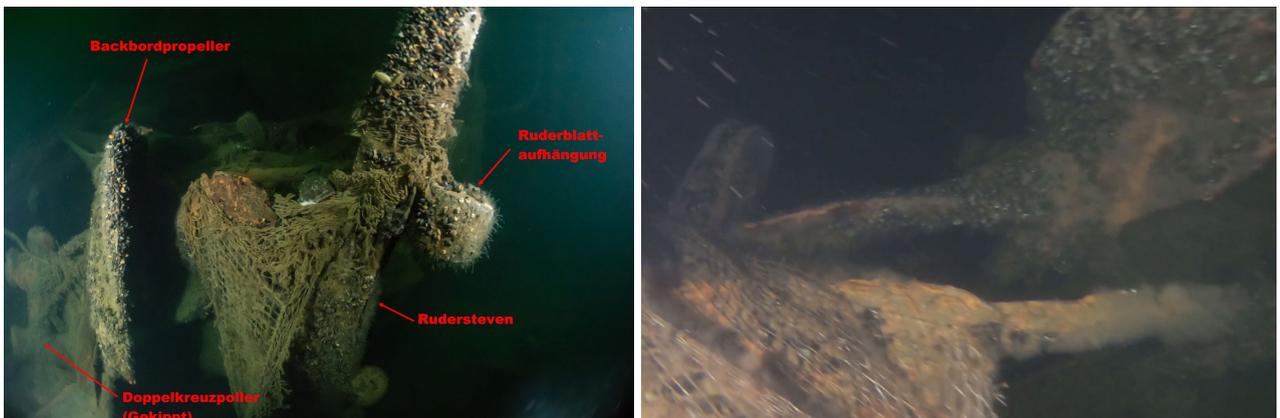
## Portside - screw

This screw is located in the rear area between remains of the stern.

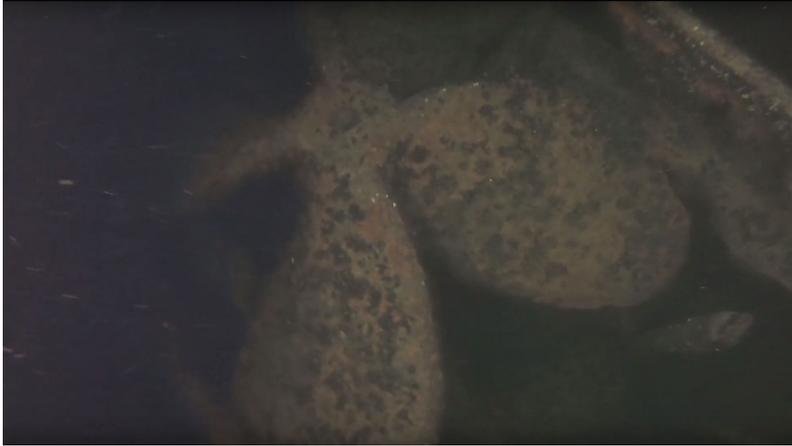
## Spare screw

A spare screw is located on deck in the rear behind the last hold. It is not connected to a drive shaft.

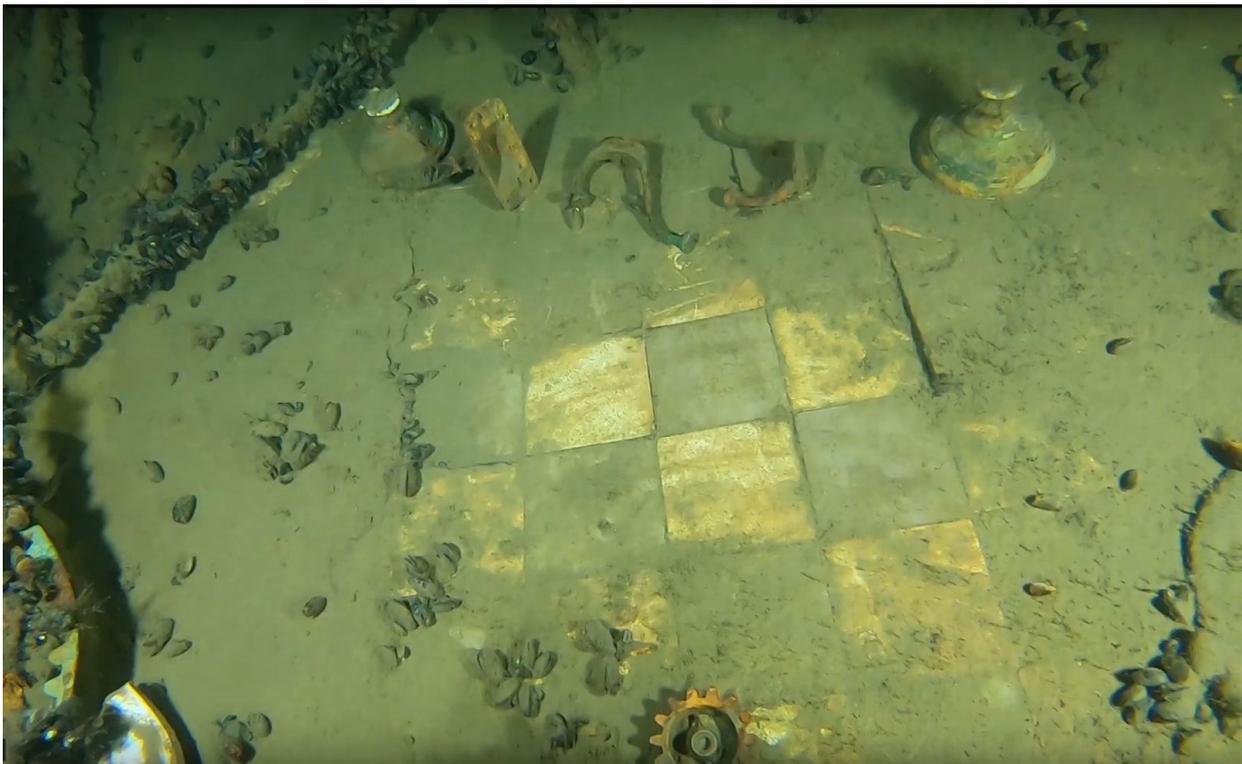
Section below the floor

Probably the bathroom of the passenger deck.

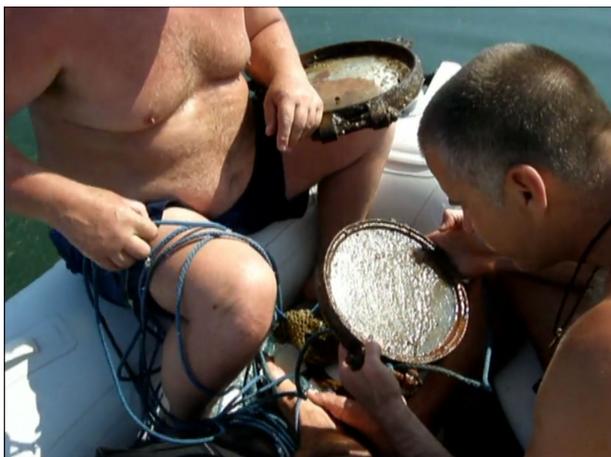
Unfortunately the wreck has already been looted.

It will only be a matter of time before the bell and steering wheel are stolen.
