# Survey report

## ELBING IX

Baltic Sea - Lithuania, Klaipeda

23.09.2019

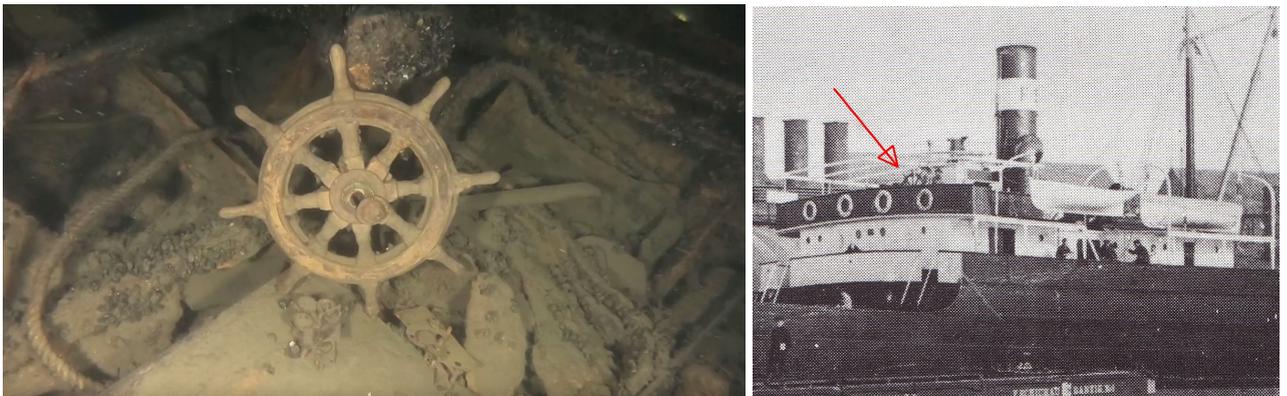
The steering wheel at the discovery on 11th July 2018

Note: the steering wheel has been set up for video recordings. After the recordings, it was placed in a sheltered place inside the wreck.

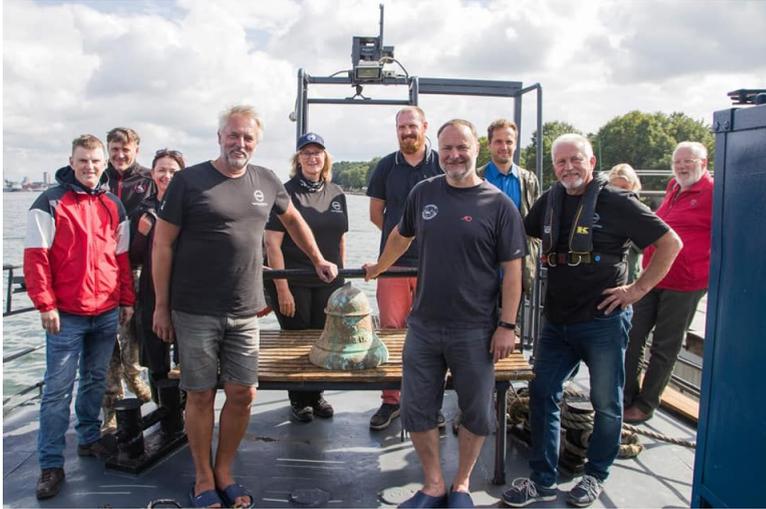
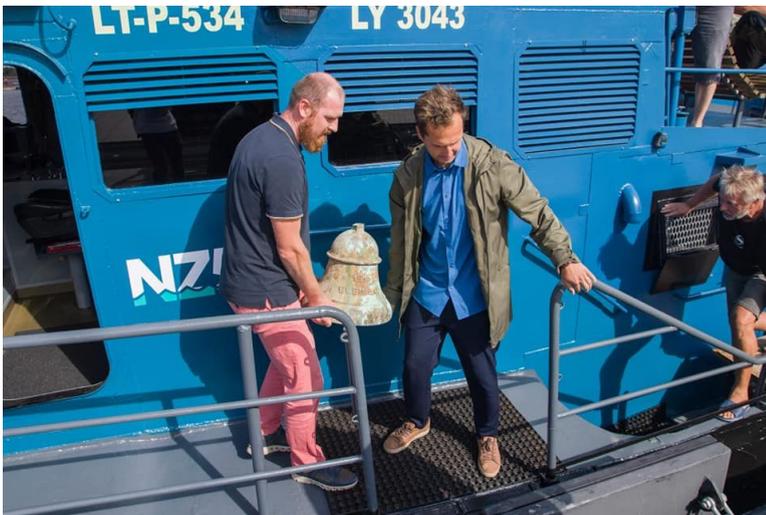
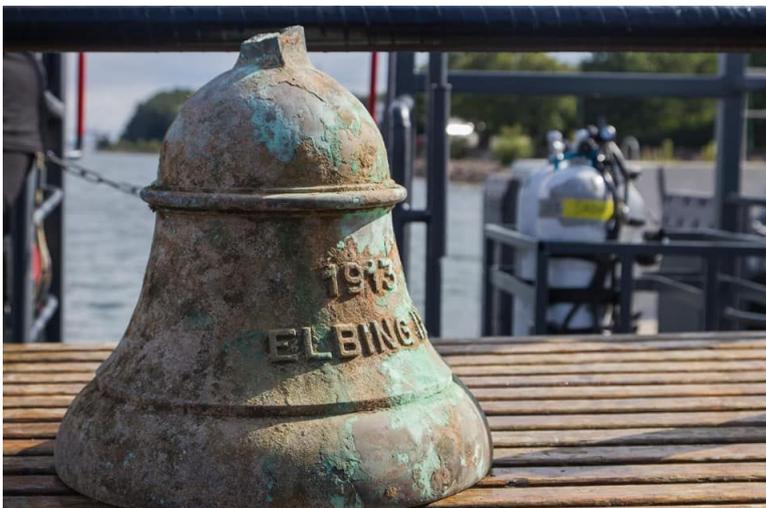
## Recovery of the bell in August 2020

In the last project week of the Baltic Sea Heritage Rescue Project 2020, the bell of Elbing IX was recovered on behalf of the Lithuanian Sea Museum in Klaipeda.

handed over to the museum

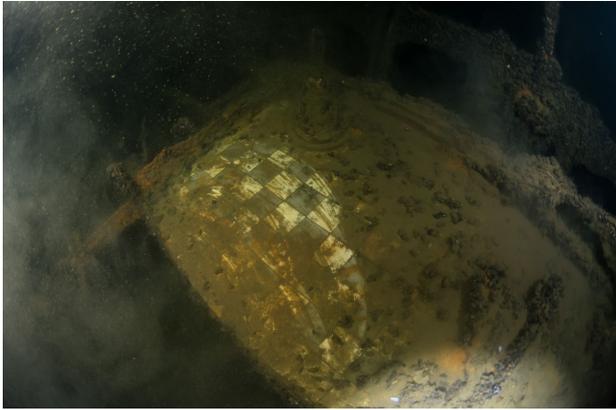
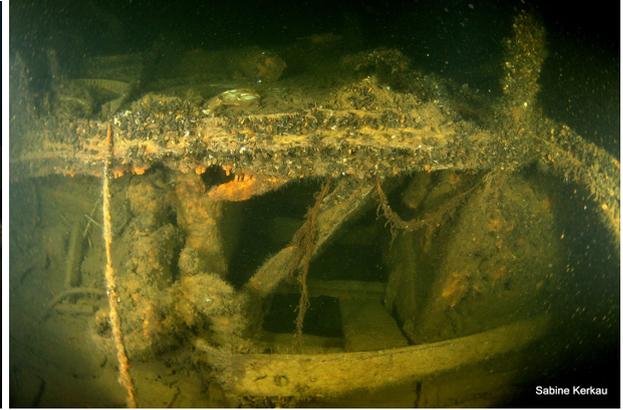
Tiled floor

Section below the floor

Probably the bathroom of the passenger deck.
